FLOOD PLAIN INFORMATION

ELLICOTT CREEK

IN THE CITY OF TONAWANDA

PREPARED FOR
ERIE-NIAGARA BASIN REGIONAL WATER RESOURCES
PLANNING AND DEVELOPMENT BOARD
By
CORPS OF ENGINEERS, U.S. ARMY
BUFFALO DISTRICT
JANUARY 1968 (REPRINTED JUNE 1971)

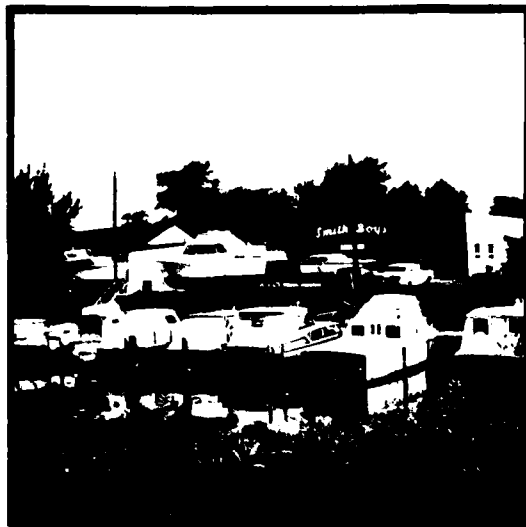
Figure 2- Photo of commercial boating facilities located at approximate creek mile 0.2.

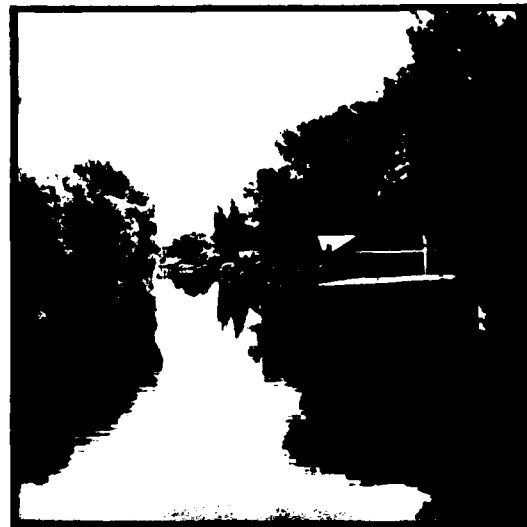
Figure 3- Photo of private boat docks. Note large trees and brush along the channel banks.

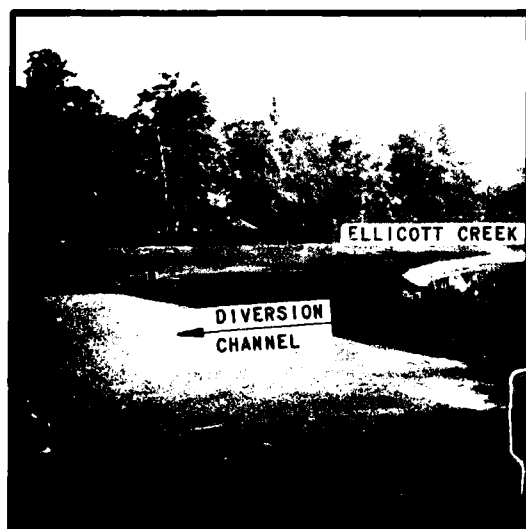
Figure 4- Photo of diversion channel located in Ellicott Creek Park. This channel is also utilized as a parking area. A part of Ellicott Creek county park is shown in the background.

In an effort to lessen the flood hazard in this reach, the County of Erie completed construction of a diversion channel from Ellicott Creek to Tonawanda Creek in the summer of 1965. There is shown in

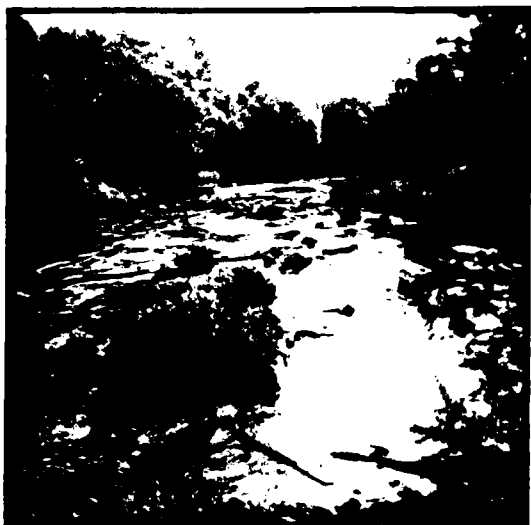
Figure 10- Photo taken looking upstream of Millersport Highway bridge.

The existing channel in this reach is covered in many locations with brush, large trees, debris and various obstructions as shown in figures 10 through 13.

Figures 10-13 all show that floodway capacity is greatly reduced by debris, weeds, brush and trees.

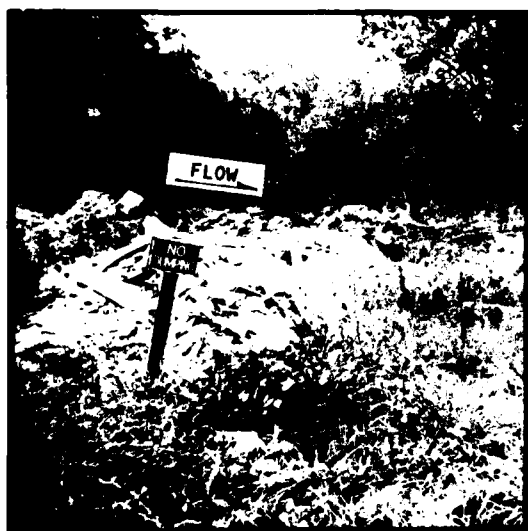
Figure 12- Photo of trash being dumped in area on right bank of Ellicott Creek near Heim Road, near creek mile 7.9.

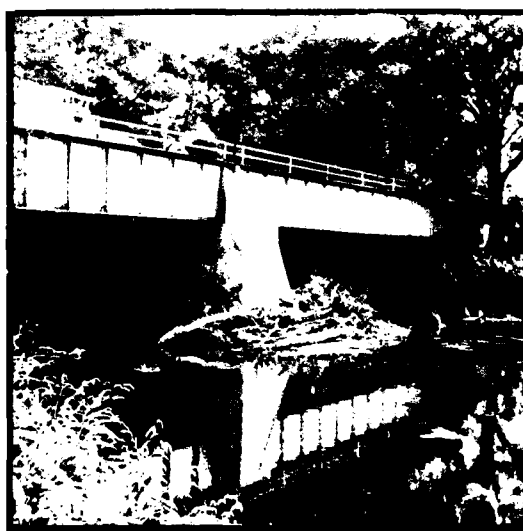
Figure 13- Photo of upstream side of Maple Road bridge. Note amount of debris collecting at center pier.

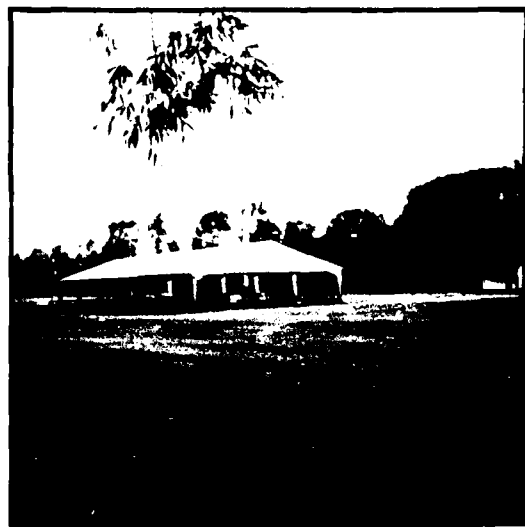
Figure 21- Looking at shelter within flood plain at Bowmansville Volunteer Fire Company Grove. Photo indicates wise flood plain usage.

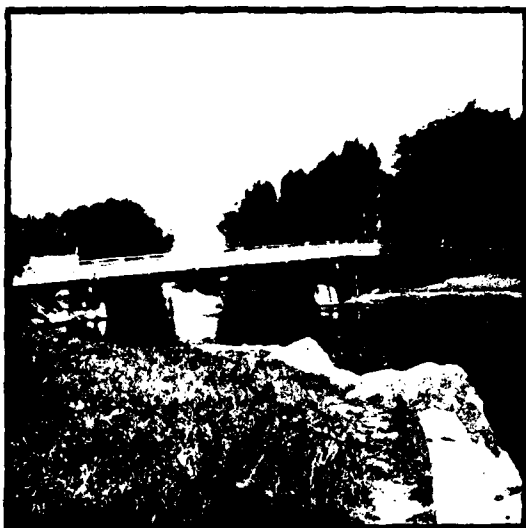
Figure 22- Looking downstream toward the Fremont Street bridge at creek mile 0.44 in the city of Tonawanda.

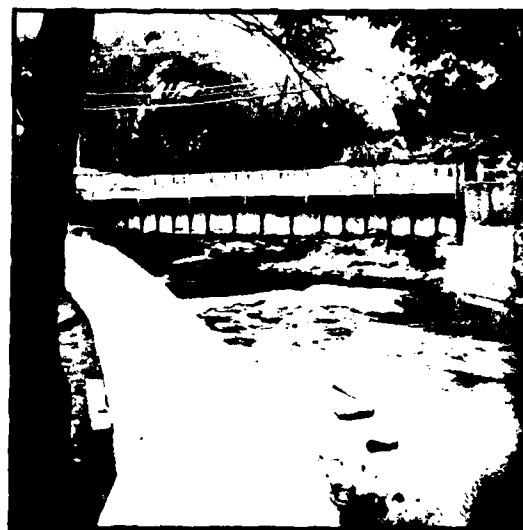
Figure 25- Looking downstream at the Glen Avenue bridge at creek mile 12.9 in the village of Williamsville. This bridge constructed in 1937 after the 1936 flood washed out the existing structure.

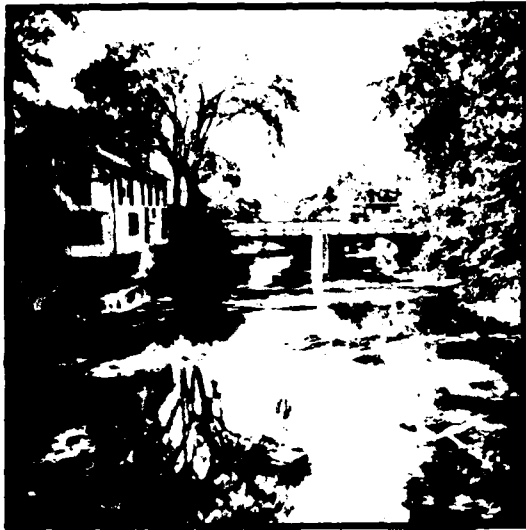
Figure 26- Looking downstream toward Main Street bridge at creek mile 13.1 in the village of Williamsville.

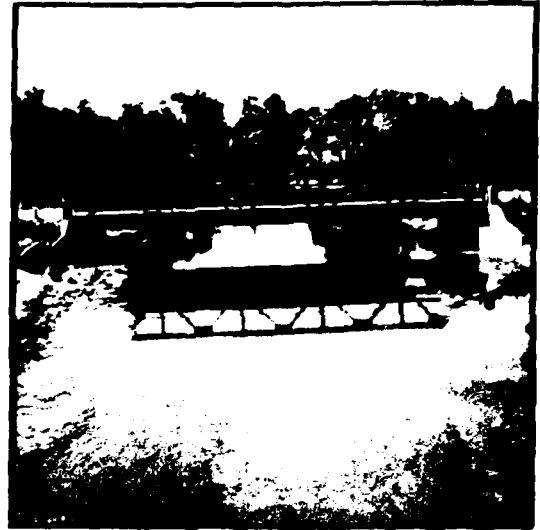
Figure 27- Looking downstream at the Youngs Road bridge at creek mile 15.07 in the towns of Amherst and Cheektowaga.

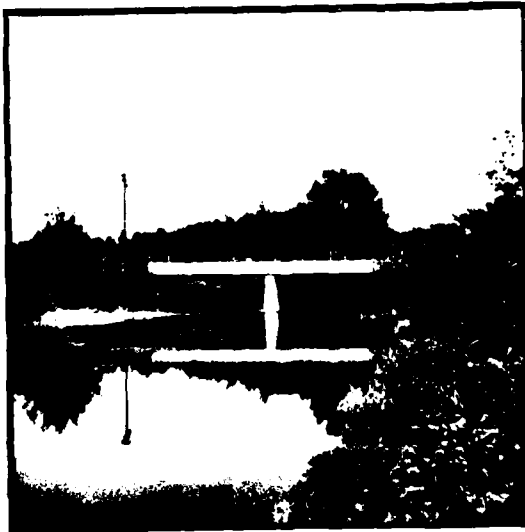
Figure 28- Looking upstream toward the Transit Road bridge at creek mile 17.1 in the town of Cheektowaga.

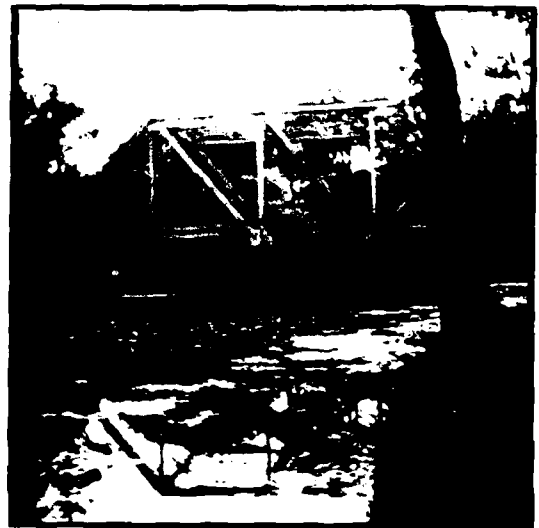
Figure 29- Looking upstream at the Harris Hill Road bridge at creek mile 18.35 in the town of Lancaster.

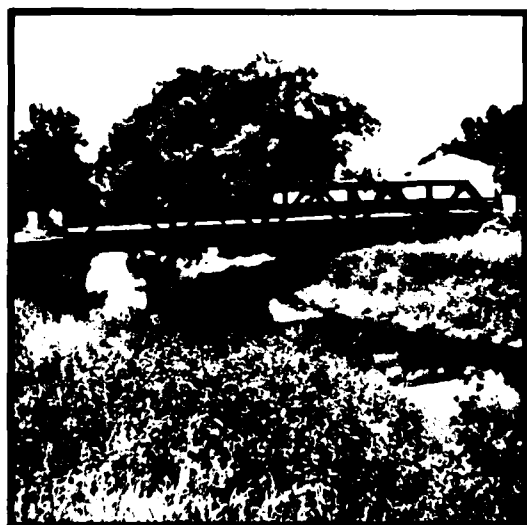
Figure 33- Looking downstream toward Rein Road bridge at approximate creek mile 16.2. Channel capacity greatly reduced due to encroachment in the channel.

The effects of obstructions to flood flows due to bridges which traverse the channel are shown on the profiles on plates 5 through 7 and in figures 30 through 37. Another serious obstruction to flood flows is the condition of the channel itself. It has many bends, has an irregular section, and in many locations is lined with heavy brush, weeds, and large trees growing on the channel banks and extending into the stream.

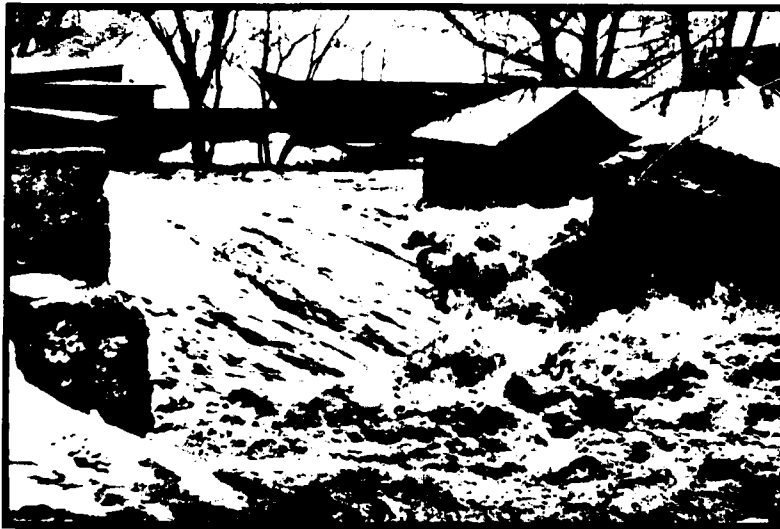
Figure C- Photo showing the remains of the Glen Avenue bridge in the village of Williamsville, at creek mile 12.9, during the March 1936 flood.

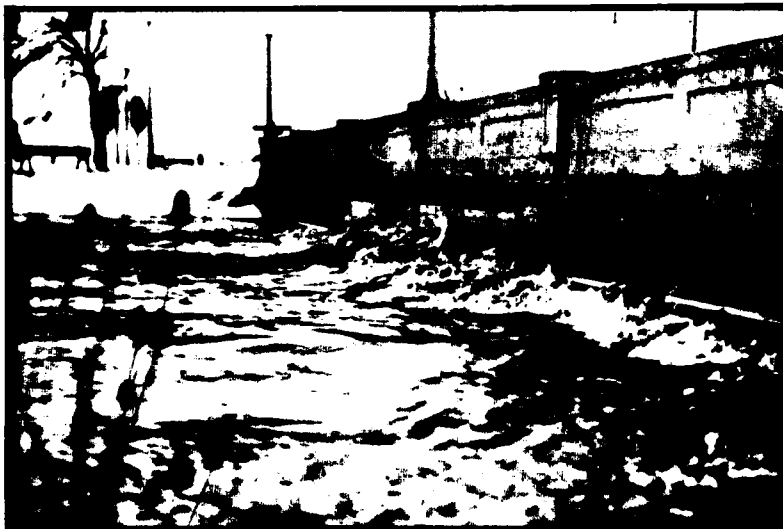
Figure D- Photo showing the water surface upstream side of Wehrle Drive bridge in the village of Williamsville, at creek mile 14.1 during the March 1936 flood.

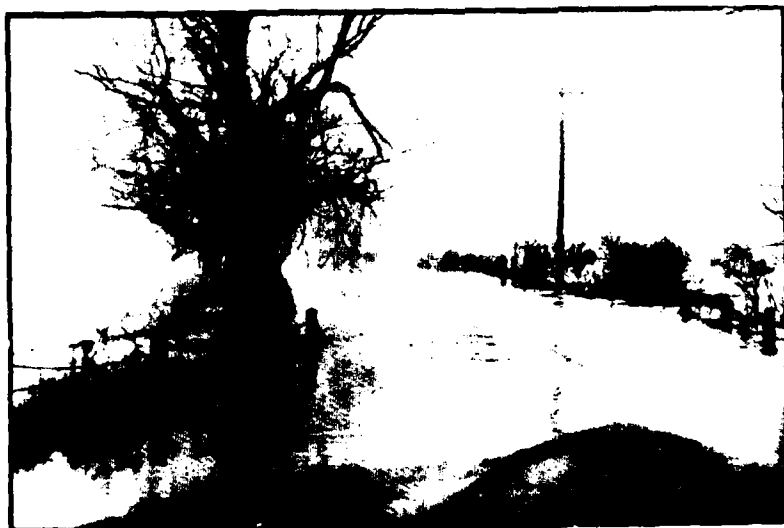
Figure F- Photo shows flood water flowing over Rein Road near creek mile 16.1 in the town of Cheektowaga during the March 1960 flood.

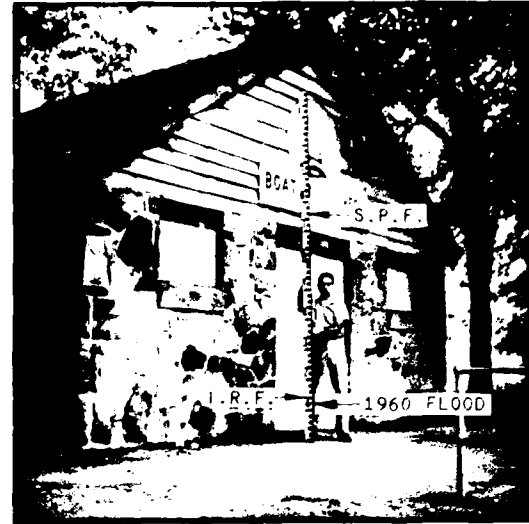
Figure 40- Arrows indicate the height of the Standard Project, Intermediate Regional and the 1960 flood at the boat house in Ellicott Creek Park at approximate creek mile 3.1 in the town of Tonawanda.

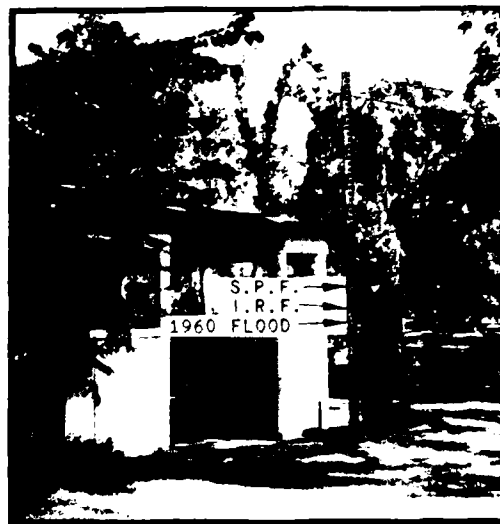
Figure 46- The Standard Project, Intermediate Regional and the 1960 flood heights are indicated by arrows at Walker's Grove just downstream of Wehrle Drive near creek mile 14.0 in the town of Amherst. Although depth of flooding is great, damages would be minor.

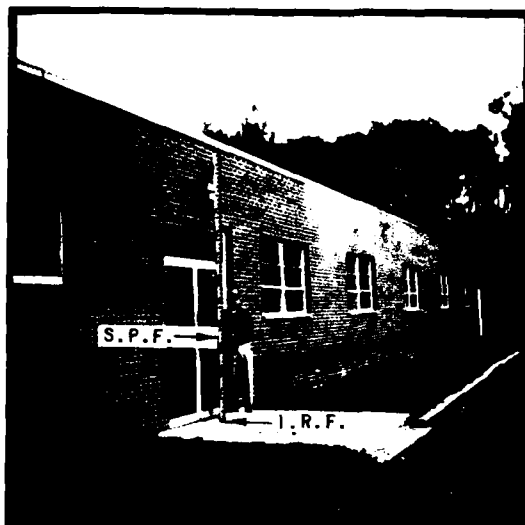
Figure 47- The Standard Project and Intermediate Regional Flood heights are indicated by the arrows at the Bowmansville Volunteer Fire Company House, near creek mile 17.8 in the town of Lancaster.

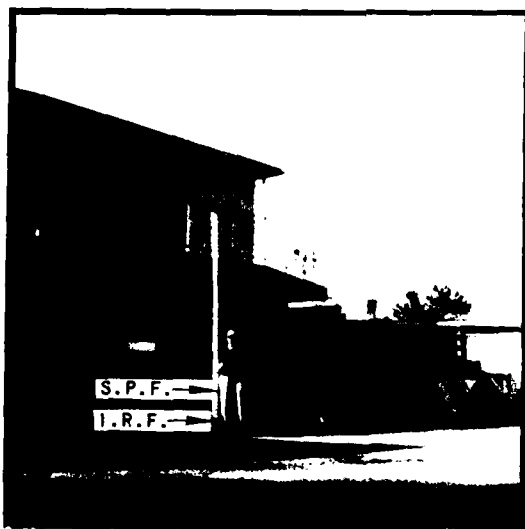
Figure 48- The heights of the Standard Project and Intermediate regional Flood heights are indicated by the arrows at the residence located just downstream of Harris Hill Road, creek mile 18.35 in the town of Lancaster.

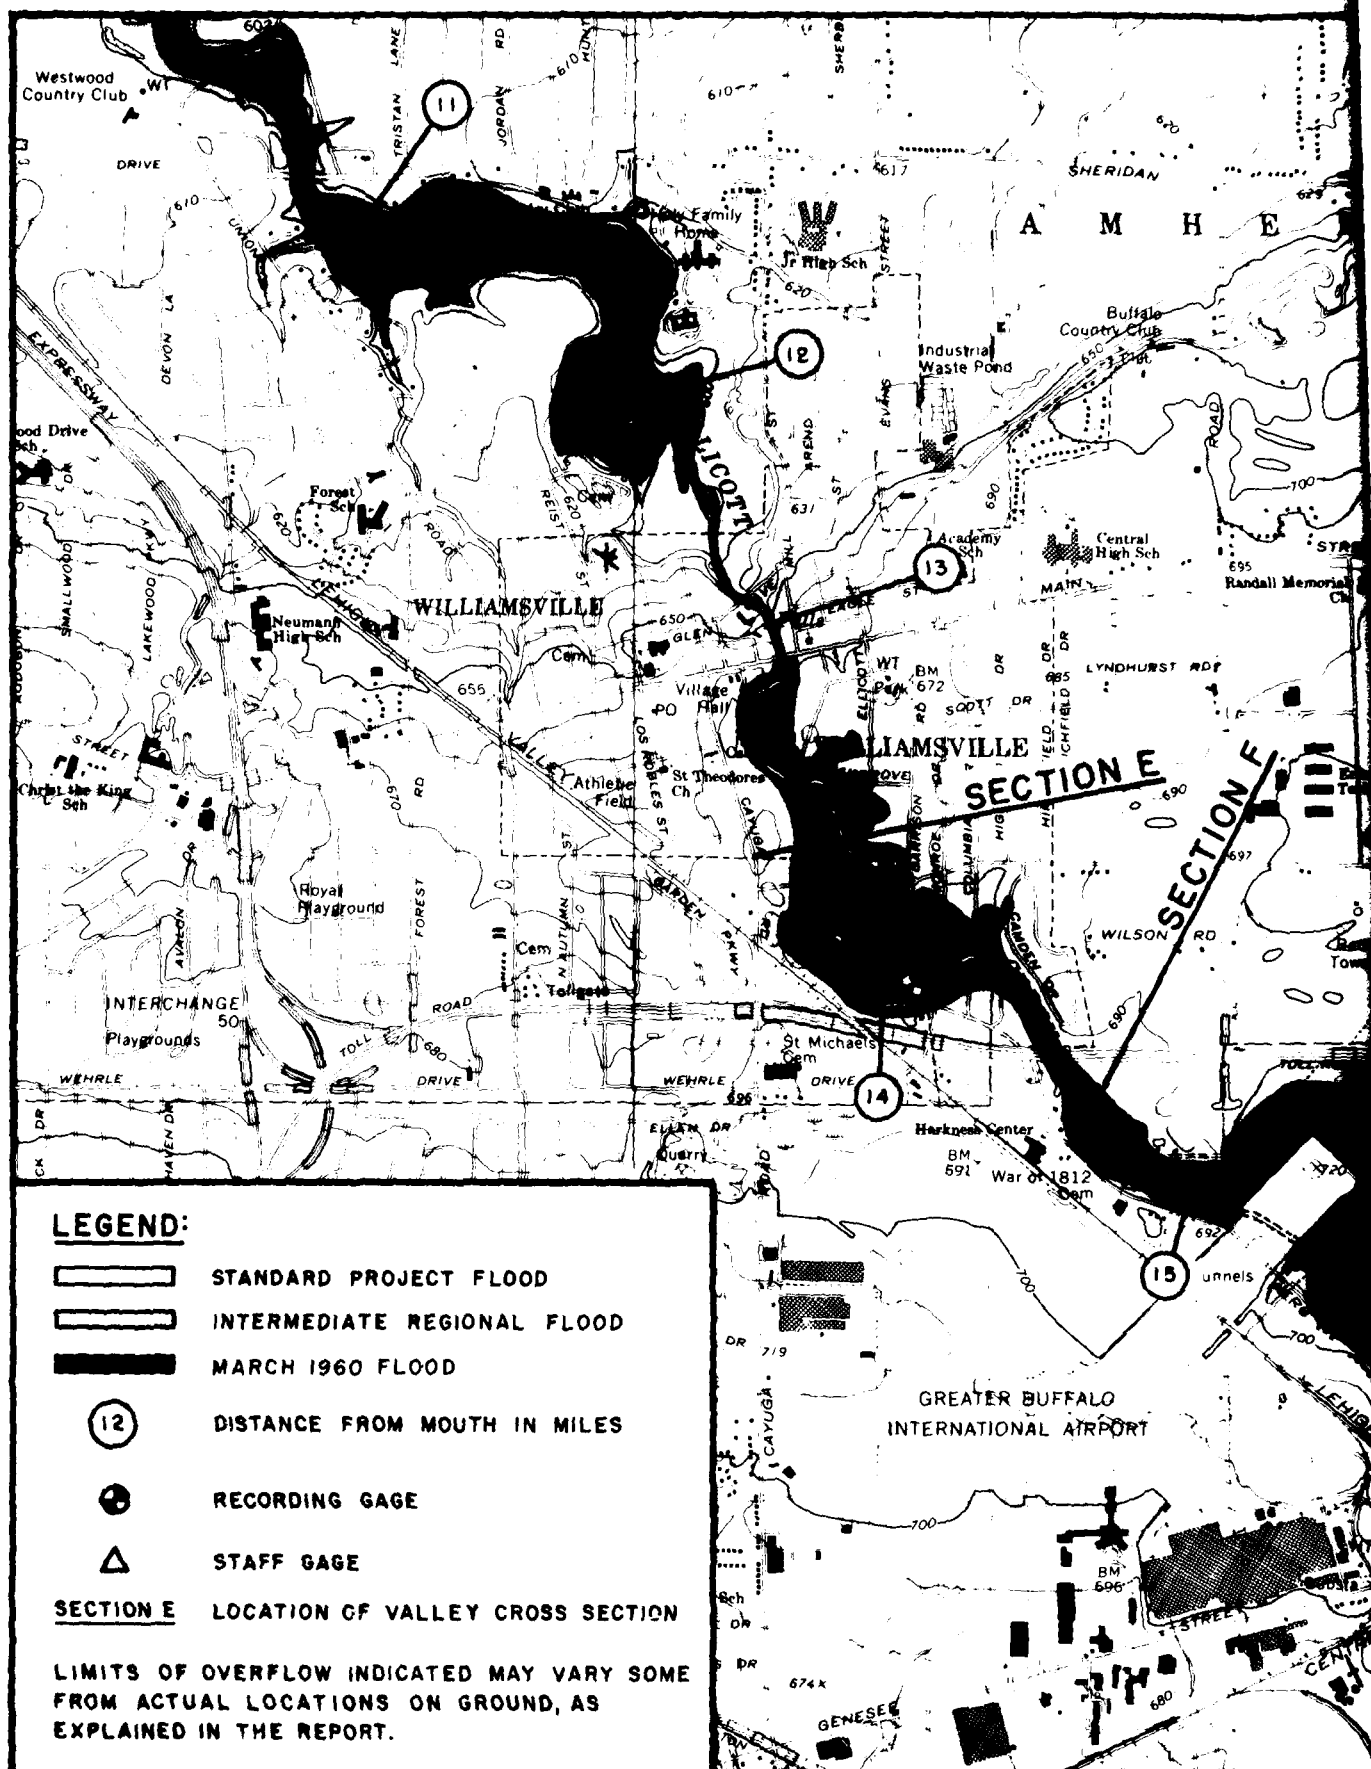
PLATE 3

ELLICOTT CREEK
ERIE COUNTY, NEW YORK
FLOOD PLAIN INFORMATION REPORT
FLOODED AREAS
MILE 10 TO 22
U.S. ARMY ENGINEER DISTRICT, BUFFALO
JANUARY 1968

Comparison of discharge measurements made during flood stages at Niagara Falls Boulevard with discharges recorded at the Wehrle Drive gage in Williamsville during the same floods, show a decrease in discharge at Niagara Falls Boulevard although the latter has an additional 29.3 square miles of drainage area. This condition is caused by the large amount of overbank storage which occurs in this reach, particularly between Sweet Home Road and Millersport Highway as shown on plate 3.

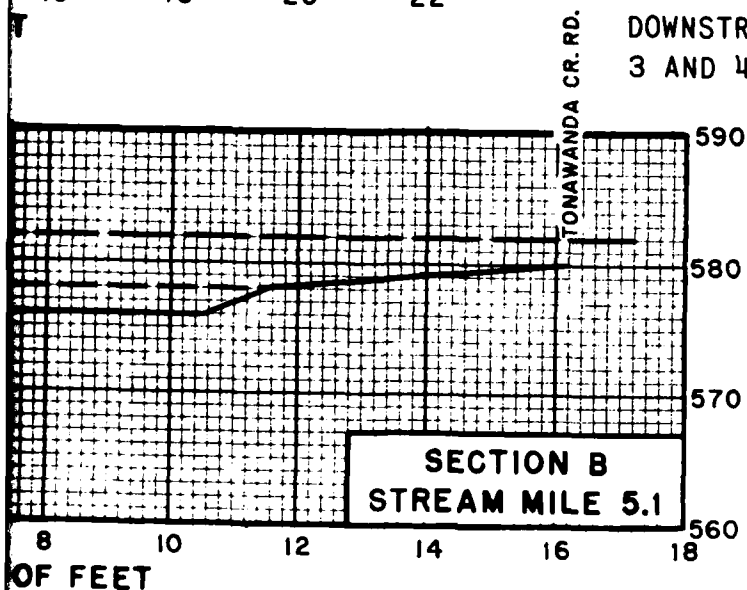
VALLEY CROSS SECTIONS ARE LOOKING DOWNSTREAM AND ARE LOCATED ON PLATES 3 AND 4.

ELLICOTT CREEK
ERIE COUNTY, NEW YORK
FLOOD PLAIN INFORMATION REPORT
VALLEY CROSS SECTIONS
A, B, AND C

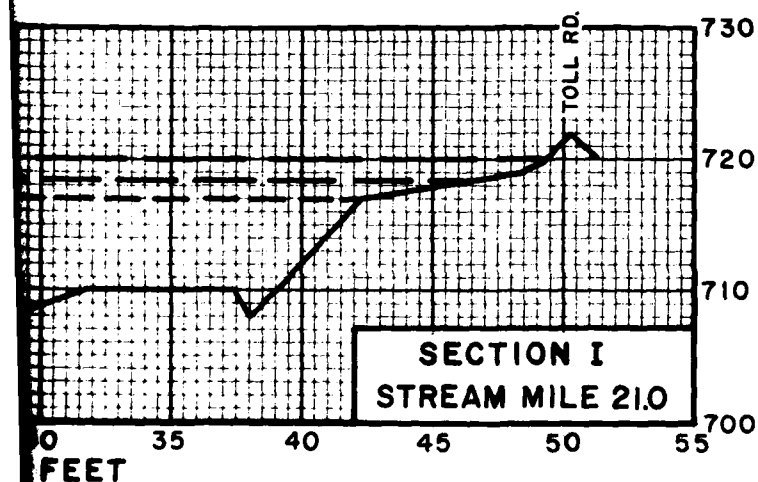
VALLEY CROSS SECTIONS ARE LOOKED DOWNSTREAM AND ARE LOCATED ON PLATES 3 AND 4.

ELLICOTT CREEK
ERIE COUNTY, NEW YORK
FLOOD PLAIN INFORMATION REPORT
VALLEY CROSS SECTION
G, H, AND I
